Important Safety Alert

Re: 100A Michaud Service Fuse Holders

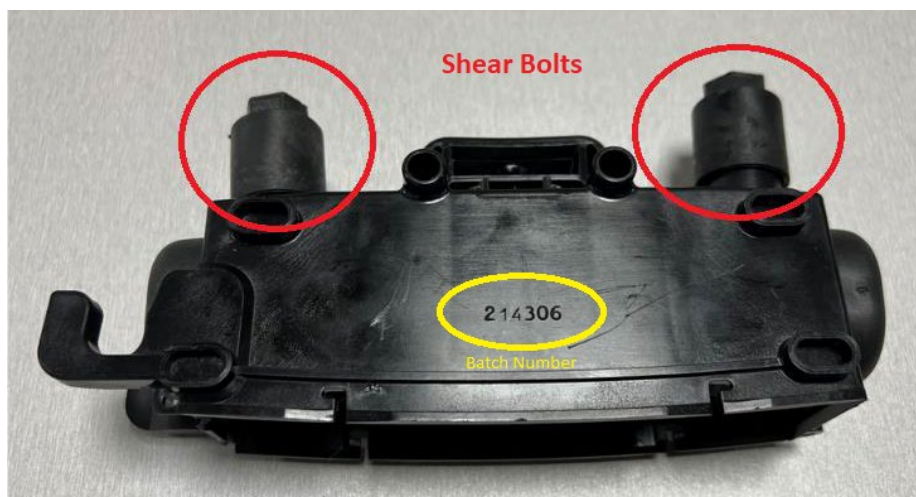
The defect is located in the shear bolts of fuse holders (*see picture below*) as they fail insulation requirements and may be conductive. The defective shear bolt may **look** like it is plastic and therefore insulated however they are conductive.

The fuse holder 'body' itself is not conductive, only the shear bolts.

To date, our investigations have determined the impacted batch number is 214306 which have been installed on sites since March 2022. TasNetworks are no longer installing this particular batch number and continue to test all service fuse holders prior to installation - however until investigations are finalised, treat all Service Fuse equipment with caution and ensure you follow the relevant safety protocols.

DO NOT make contact with the 100A Michaud Service Fuse Holders and ONLY OPERATE if you have the accredited Level 2 - Authority to Operate.

If you are onsite and identify 100A Michaud Service Fuse Holders from batch number 214306, please contact **TasNetworks on 132 004** or [submit a form](#) with the location **Note: The batch number may not be easily identifiable and we are only asking you to report this if it is clearly visible without having to move any assets.**
